# Water safety planning and implementation in a Ghanaian small-scale water supply system

**Aims:** This study looked at the Assin Fosu Small Town Water Supply System to verify whether the operation of the scheme is based on a comprehensive water safety plan and how the practice of water safety planning affects the quality of water delivered to the consumers.

**Place and Duration of Study:** This study was conducted in March - July 2014 on the Assin Fosu Small Town Water Supply System in the Central Region of Ghana.

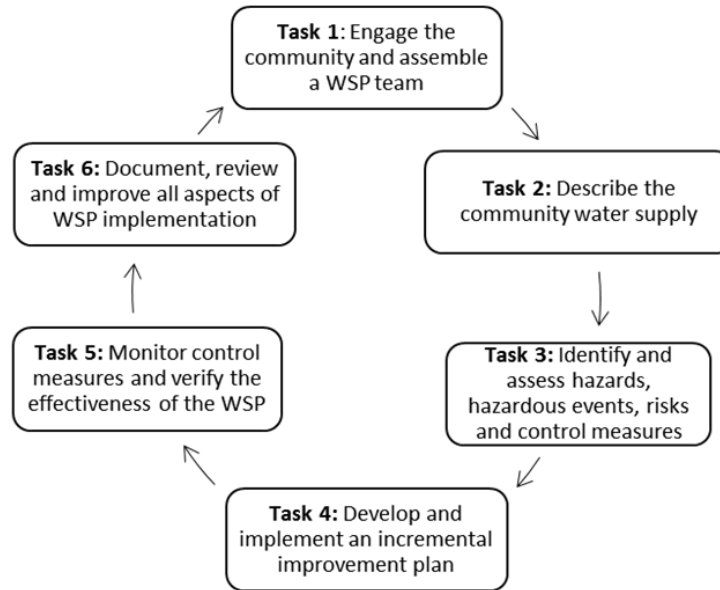
88  
89 **Fig. 1. Water safety plan continuous improvement cycle**  
90 *Source: WHO [8]*  
91

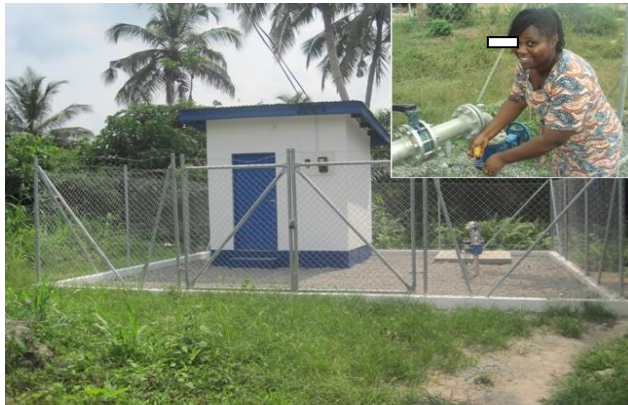
Plate 2 Water source – borehole and pumping station – at Assin Fosu (Credit: Authors)

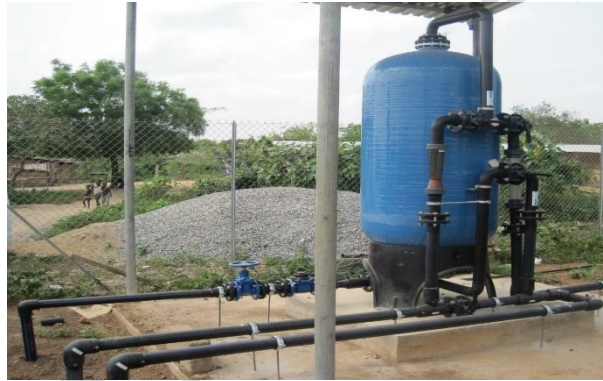
Plate 3 An Aquatec filtration unit installed in the AFSTWSS (Source: ANMA [20])

427 It was expected that the high colour and turbidity of the raw water would be reduced to the  
428 recommended levels after undergoing treatment in the filtration units but the reduction  
429 observed was marginal and inconsistent as seen in Table 4. This could be attributed to  
430 inefficient filtration which could primarily result from poor management of the filtration units.  
431 The management of the filtration units was one of the areas where the stipulated operational  
432 (regeneration) schedule was not strictly followed.

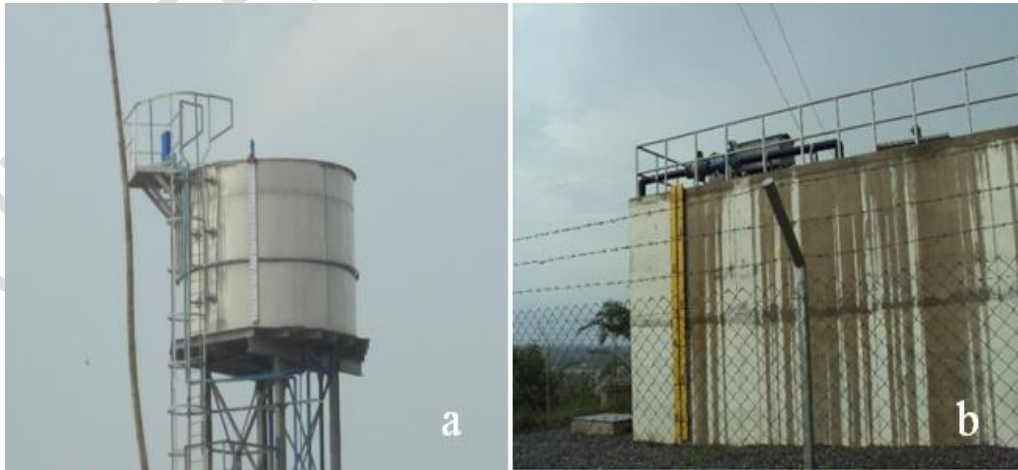
Plate 4. Service reservoirs of the AFSTWSS (a) Elevated aluminium reservoir; (b) Ground-level concrete reservoir (Source: ANMA [20])
