2
3 **Water safety planning and implementation in a**
4 **Ghanaian small-scale water supply system**

This study looked at the Assin Fosu Small Town Water Supply System in Ghana to verify whether the operation of the scheme is based on a comprehensive water safety plan and how the practice of water safety planning affects the quality of water delivered to the consumers. The study employed document reviews, structured observations, interviews and laboratory analysis of water samples. System design data files and an Operation and Management Contract document were reviewed along with in-depth interviews with key stakeholders of the water supply system. Structured observations were made to assess the management practices of the system managers. Three rounds of sampling of water were done at monthly intervals from 10 randomly selected public standpipes, 3 boreholes and 2 filtration units. Samples were analysed to assess their bacteriological safety and aesthetic (physical) quality (turbidity and colour). Upon detection of bacteriological contamination, the adequacy of disinfection was assessed by measuring the levels of residual chlorine. It was found that the recommended schedule for s

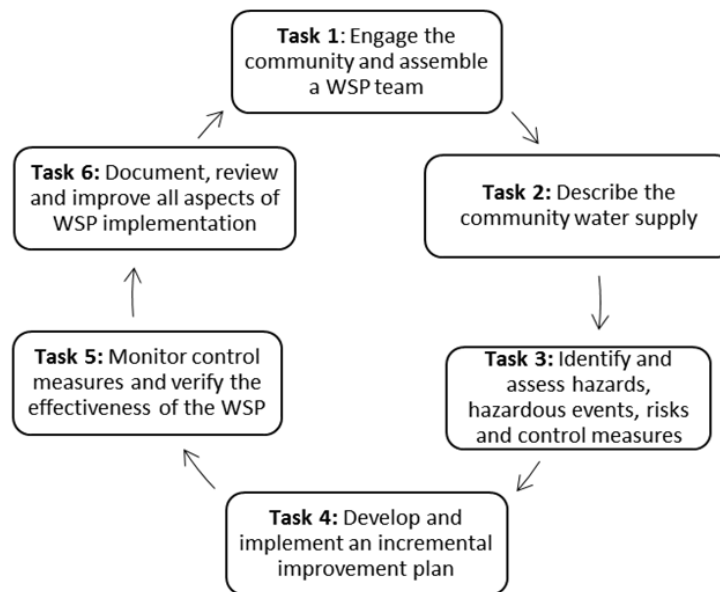
85
86
87
88
89
Fig. 1. Water safety plan continuous improvement cycle
Source: WHO [8]

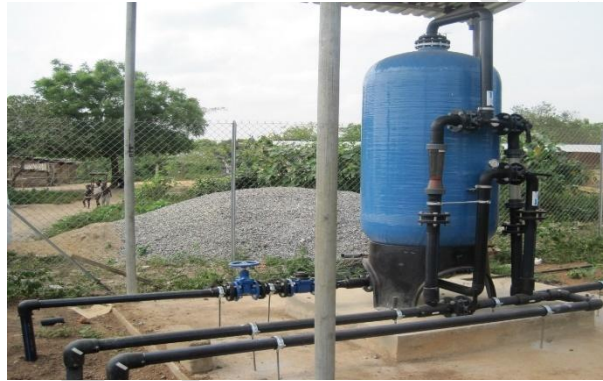
Plate 2 An Aquatec filtration unit installed in the AFSTWSS (Source: ANMA [20])

422 the geological formation of the area. The high iron levels in the groundwater may have
423 necessitated the installation of the Aquatec filtration units.

429 It was expected that the high colour and turbidity of the raw water would be reduced to the
430 recommended levels after undergoing treatment in the filtration units but the reduction
431 observed was marginal and inconsistent as seen in Table 4. This could be attributed to
432 inefficient filtration which could primarily result from poor management of the filtration units.
433 The management of the filtration units was one of the areas where the stipulated operational
434 (regeneration) schedule was not strictly followed.

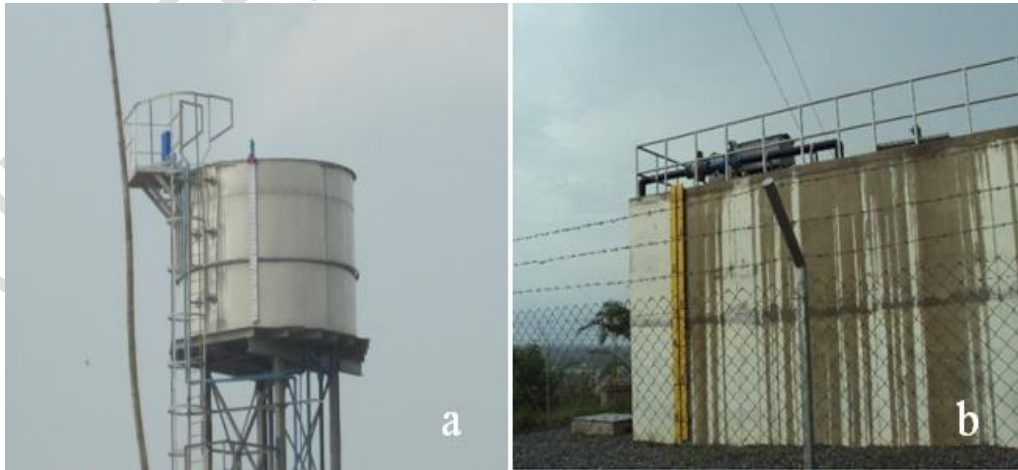
Plate 3. Service reservoirs of the AFSTWSS (a) Elevated aluminium reservoir; (b) Ground-level concrete reservoir (Source: ANMA [20])
